GERB Operations Report

GIST 34 - Toulouse - 8th Oct 2014

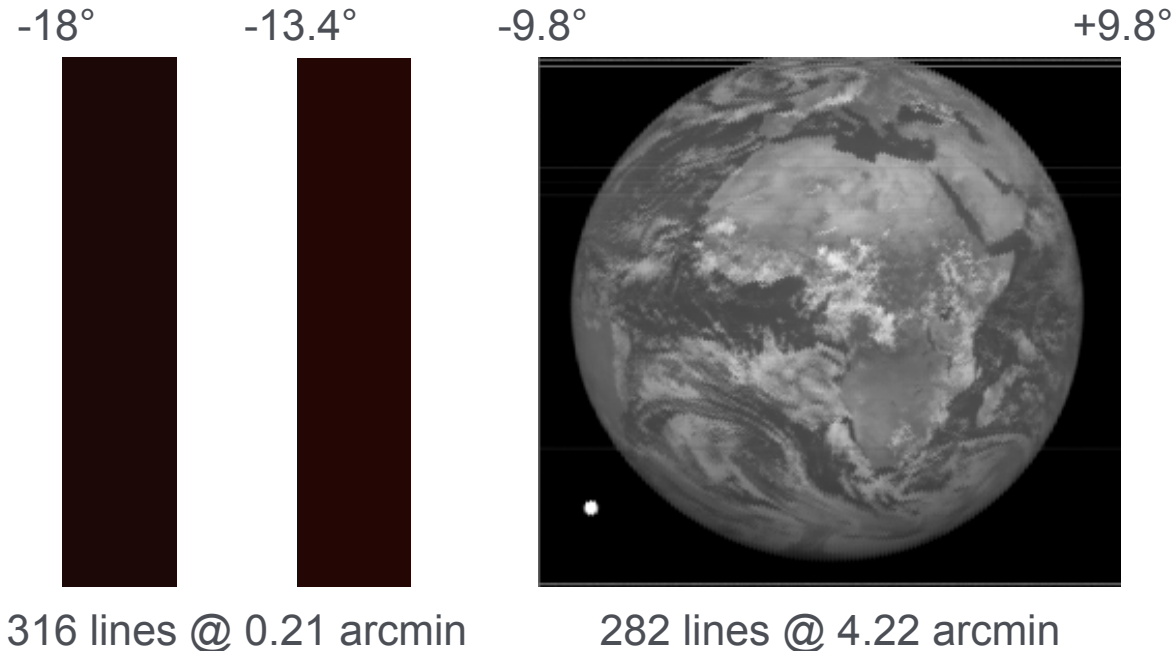
Lunar Observations

Moon not frozen by despin mirror, moves west to east as columns scanned.
SW scans observed in deep space window beginning 18° from NORMAL image center.
TOTAL scans begin 13.4° from NORMAL image center, moon observed over ~10 mins
thus three images in each region.

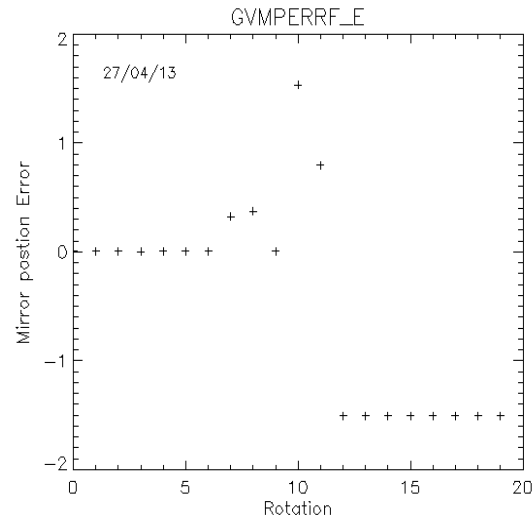
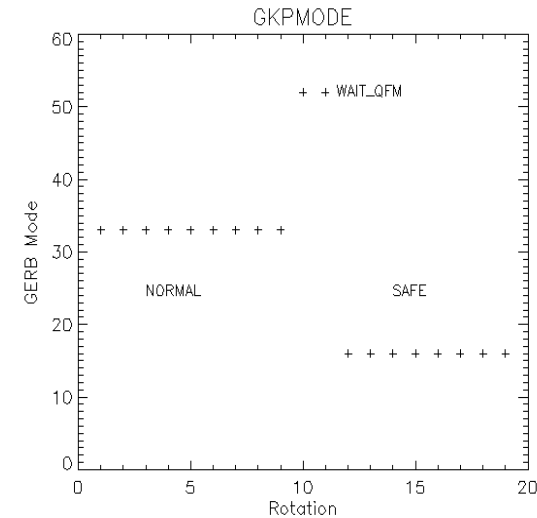
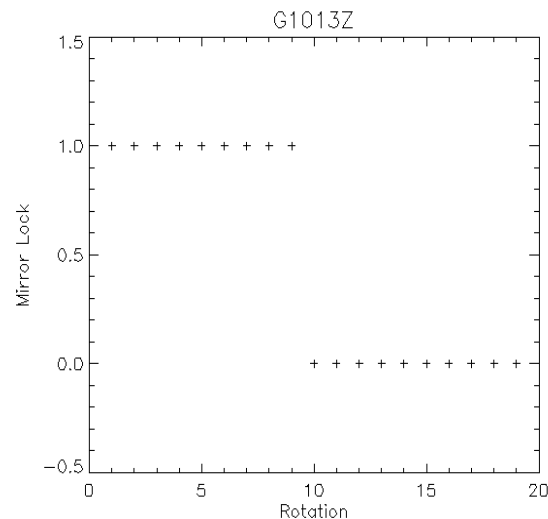
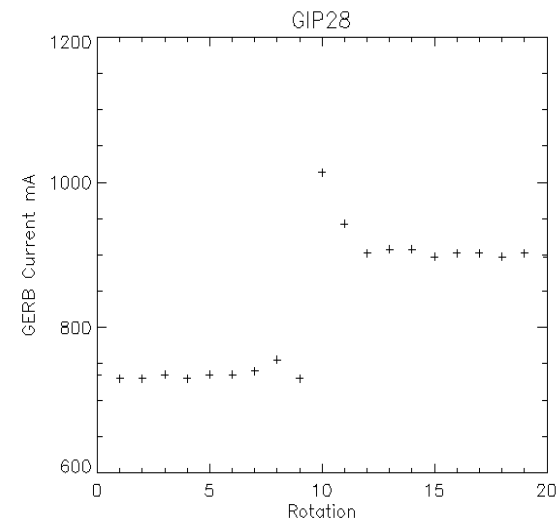
Incident #51

27th April 2013 at 05:56 (All times UTC)
GERB-3 experienced a loss of lock on
the DSM which caused an AutoSAFE.

In the next hour GERB-3 periodically
exceeded a warning limit on instrument
current (G1015Z, 1040 mA) and was
switched off at 06:55.

The instrument was recovered to SAFE
mode at 10:30 on the 27th.

Subsequent commanding to NORMAL
mode failed to achieve mirror lock in
SUNBLOCK on two instances (29th April,
2nd May.) Each time the instrument was
returned to SAFE and the DSM disabled.

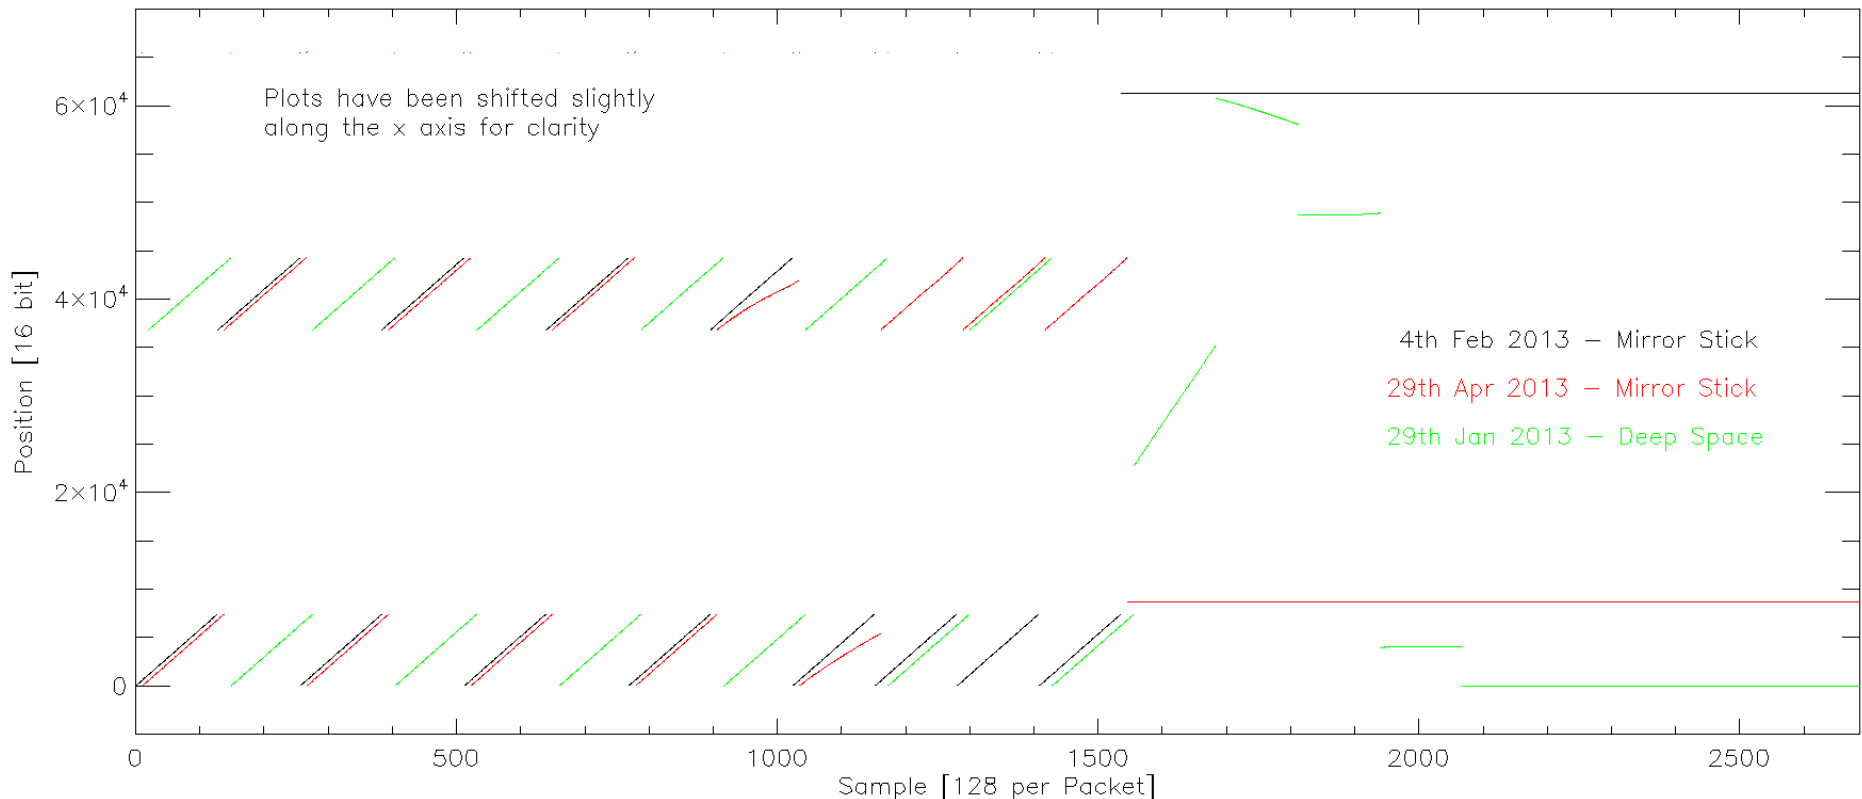
Comparison of Mirror FIFO data

128 mirror position values are given by the FIFO for every rotation for the Earthview regions. The mirror is driven successfully to position zero in the case of the Deep Space threshold violation but for the mirror sticking events no further movement in the DSM is recorded in either case. In case of mirror anomaly FIFO data is repeated (last two red and three black packets before SAFE) as no new valid mirror data is supplied.

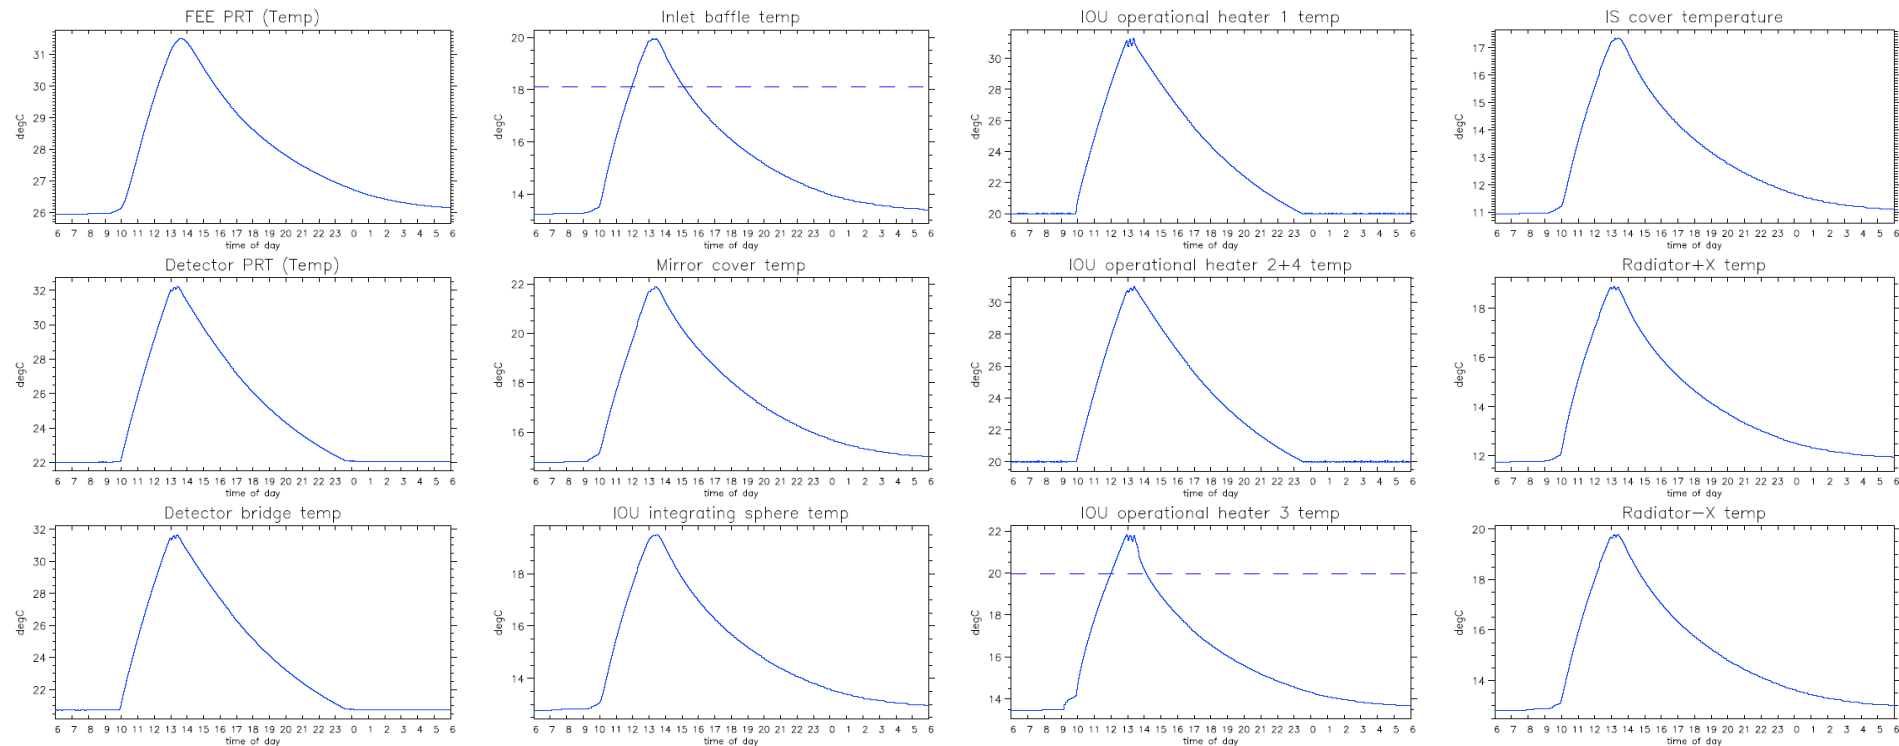
Regular and Thermal Tests

A regular test of the GERB-3 bearing was attempted twice a week based on the example of the jam on ATSR which was resolved after its mirror was commanded each overpass.

Over the course of 6 months (Oct '13- Mar '14) 31 tests including 6 using the survival heaters to raise the GERB baseplate temperature were attempted.

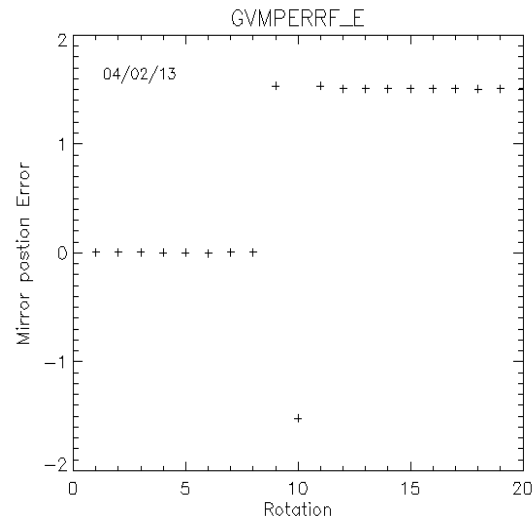
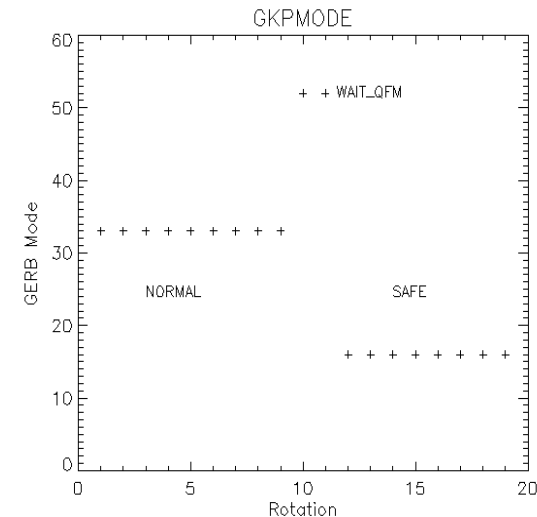
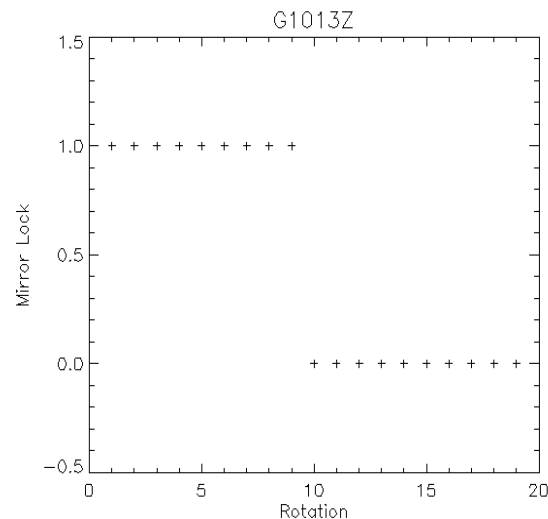
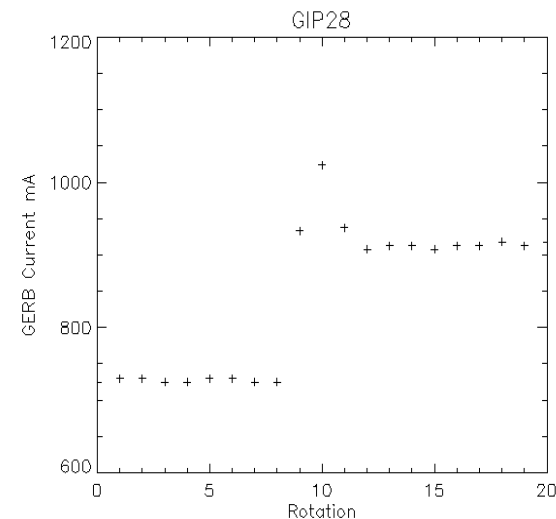
February GERB-3 DSM Incident

A similar event has occurred once before on GERB-3 at 19:28 on 4th February.

After two OOL packets on GVMPERRF the hardware in-lock flag was deasserted and the AutoSAFE transition began.

In this case the instrument also raised alarms on the inner, high current limits overnight as the mirror attempted to drive to its zero position.

The instrument was power cycled at 09:00 on the 5th of February and successfully recovered to SUNBLOCK at 15:00 on the 6th and to NORMAL at 11:00 on the 7th.

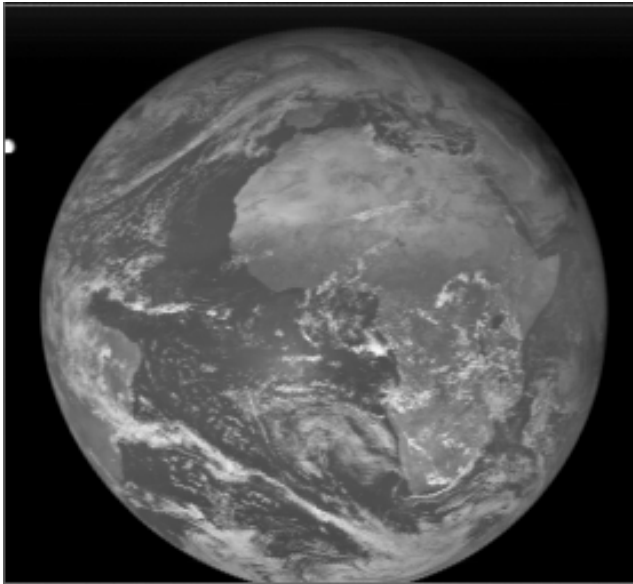
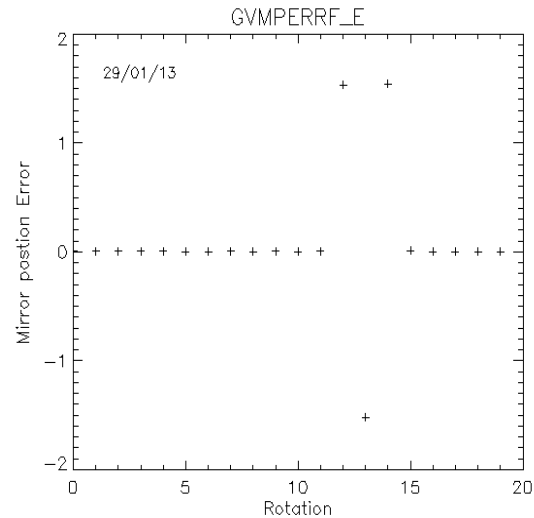
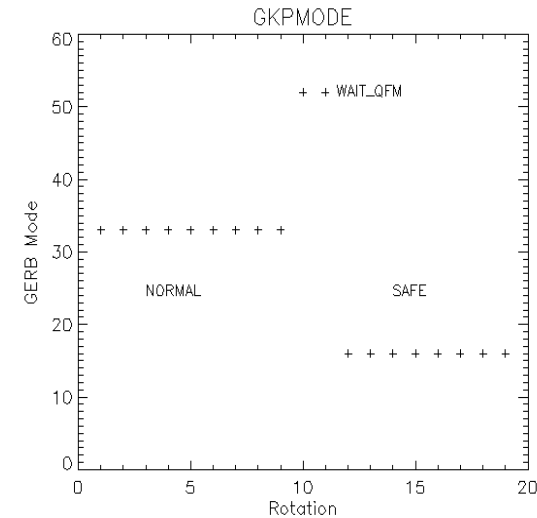
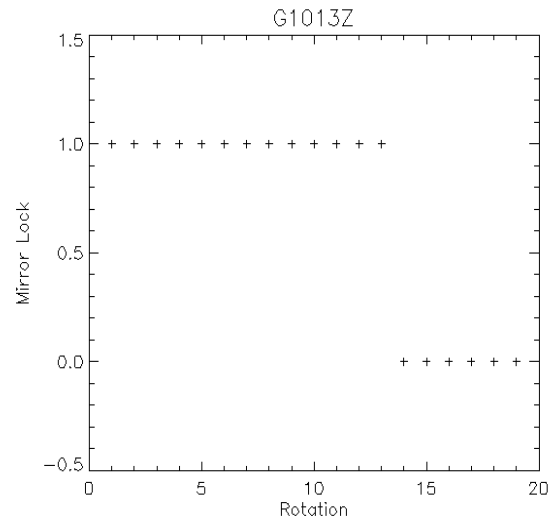
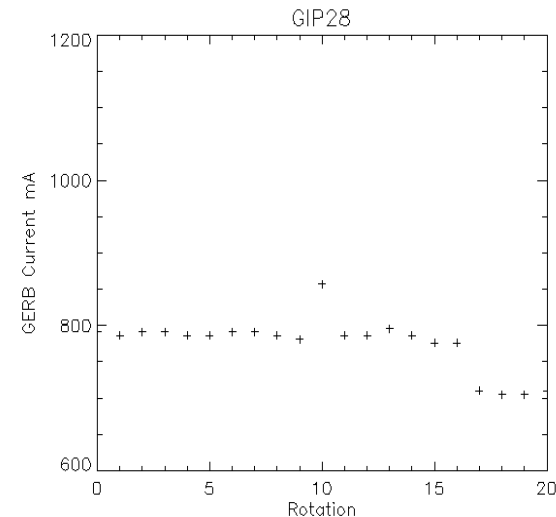
AutoSAFEs on Deep Space Test

GERB-3 has experienced three more AutoSAFE incidents since launch caused by high signal tripping the deep space column checks.

In these cases no current limits are violated in SAFE mode after the event.

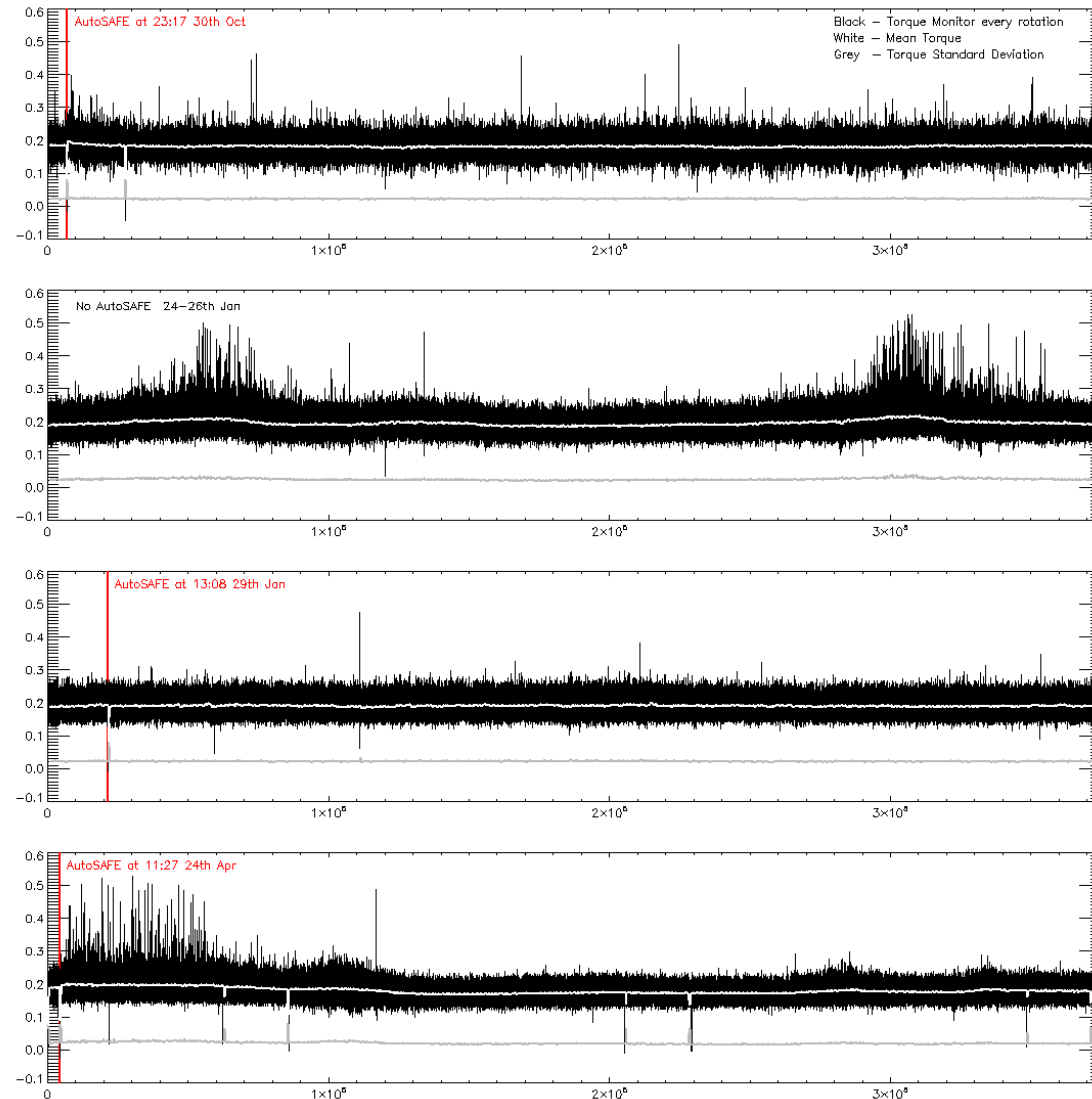
Connection between AutoSAFEs?

In analysis of the two DSM events on GERB-3 it was noted that they were both preceded by AutoSAFE events on the stray light checks.

To ensure no causal connection the torque monitor data was examined in those two incidents and the event from October.

Data is also shown from late in January 2013 when no safety transitions took place.

The proximity appears to be coincidental.

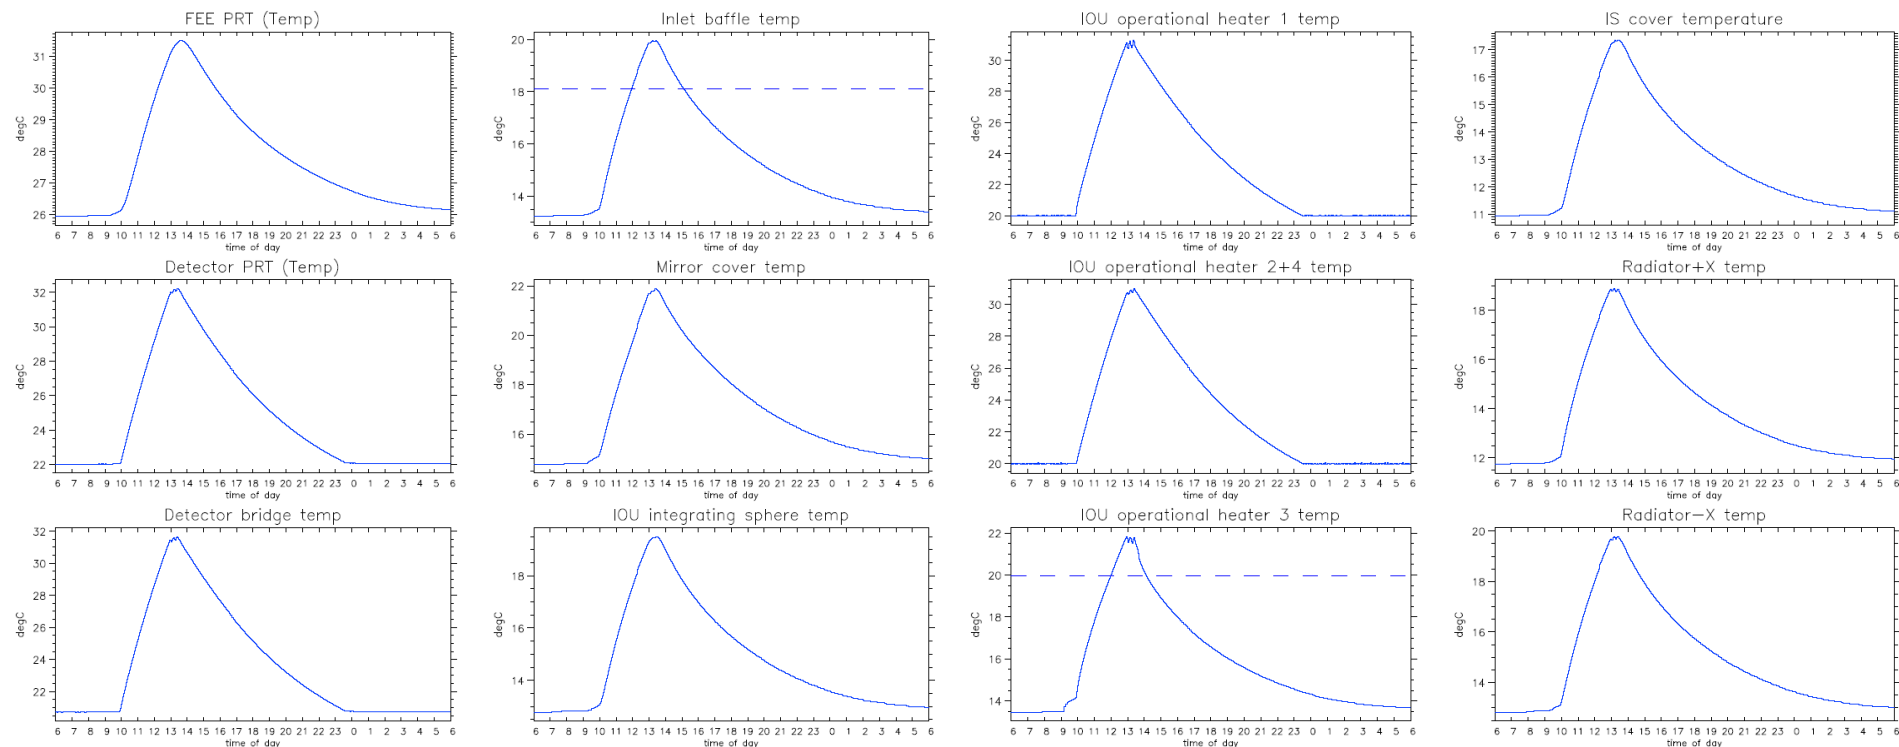
GERB-2 Heating Test

A planned test to heat the GERB-3 instrument and activate the DSM to free the mechanism led to a preparatory test on GERB-2.

The GERB operational heaters have insufficient power, and are poorly placed to preferentially heat the DSM so the survival heaters were used instead.

The succesful test showed that the GERB-3 baseplate could be raised 7 degrees without endangering the detector or adversely effecting SEVIRI full Earth scans.
